**ARBORIST REPORT  
LINCOLN SQUARE PROJECT  
DIXON, CALIFORNIA**

**Prepared for  
RANEY PLANNING AND MANAGEMENT, INC.  
SACRAMENTO, CALIFORNIA**

**Prepared by  
TREE ASSOCIATES  
John M. Lichter, M.S.  
ASCA Registered Consulting Arborist #375  
ISA Certified Arborist #863  
ISA Qualified Tree Risk Assessor  
ASCA Qualified Tree and Plant Appraiser**

**June 20, 2021**

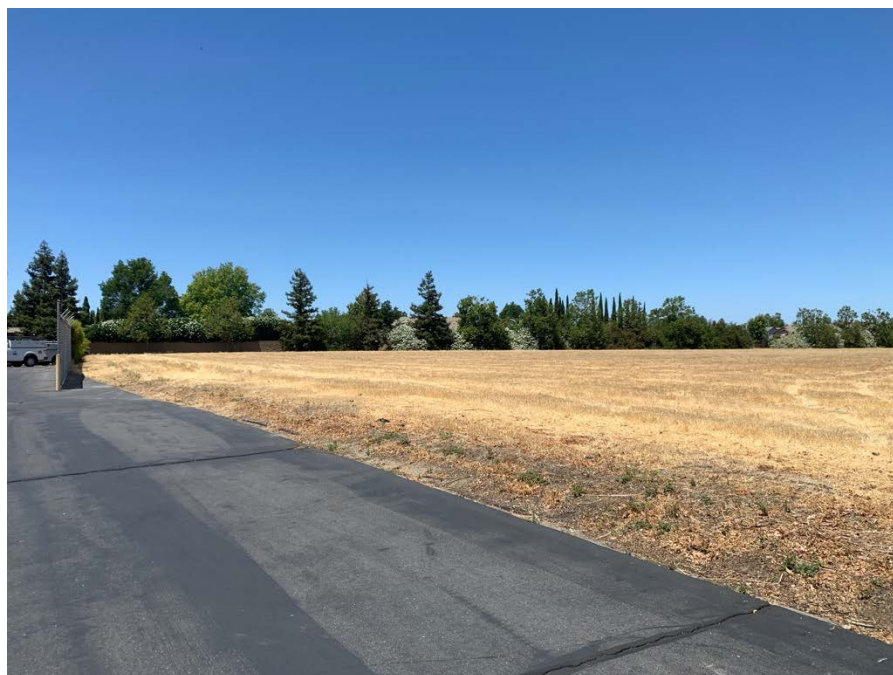
There were 31 trees with trunk diameters of six inches or greater located in a row along the western edge of the property (Figures 2,3). Other than five volunteer trees, the trees had been planted on site.

Figure 2. Looking west-northwestward at a portion of the subject trees in the southern portion of the landscaped edge of the lot. The residences are located behind the trees.

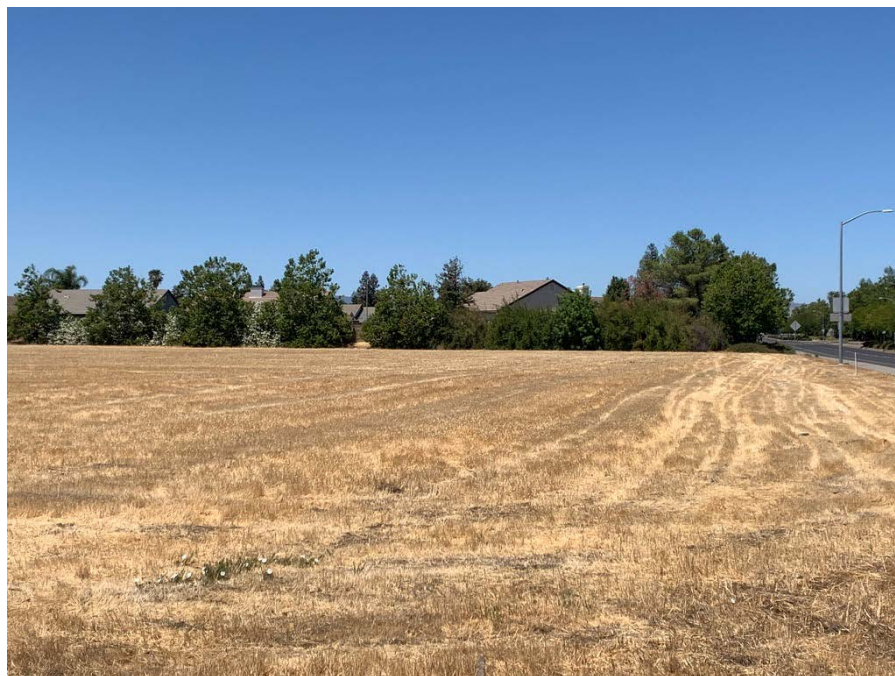
**Figure 3. Looking westward at a portion of the subject trees with Vaughn Road visible on the right.**

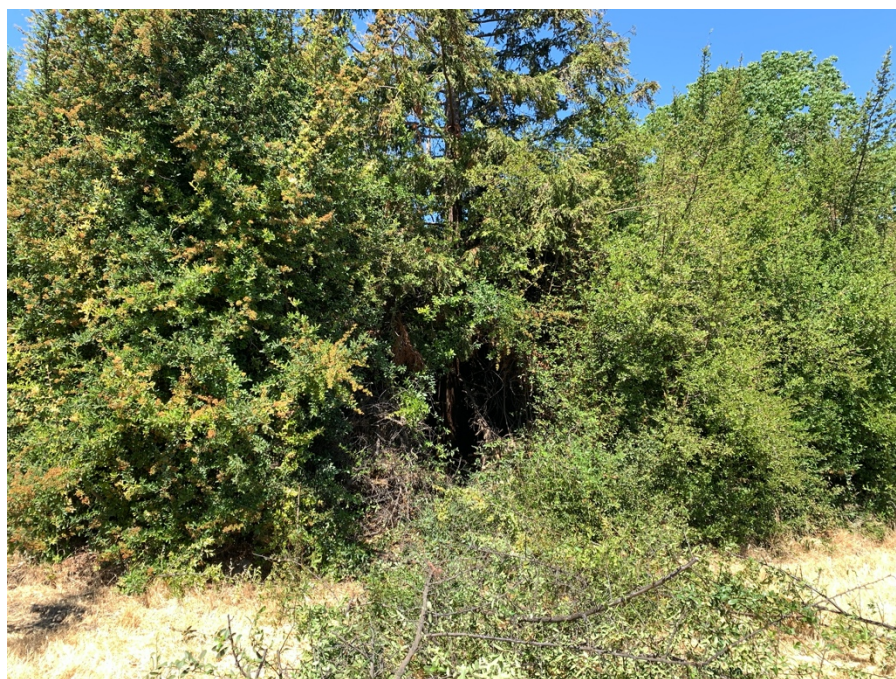
Pyracantha (a shrub) had been along with the trees and it was now a dense, nearly impenetrable thicket extending. In some cases its growth extended  $\frac{3}{4}$  of the way up the tree trunks. In several locations I had to cut my way through it to get to the tree trunks (Figure 4).

**Figure 4. Example of pyracantha growth under one of the trees. I cut a tunnel through it to get to the tree's trunk.**

In several cases, pyracantha had grown over the branches of the trees. The shade cast by their foliage may have killed some of the branches (or portions of them) and the pyracantha should either be removed or cut back to clear the tree canopies.

- Remove the four trees (13% of the total) as recommended in Exhibit 1 due to their poor health and/or structure and the lack of effective treatments to improve their condition.
- Cut the pyracantha and oleander back so that it does not shade the trees and to enable repairing the irrigation system.
- Repair or replaced the irrigation system so that it is capable of uniformly wetting the soil under the canopies of the trees.
- Irrigate the trees (between late spring through early fall) once per week, wetting the soil to at least 18 inches deep.
- Evaluate the health of the trees just before the irrigation system is installed and monitor the trees' health throughout the summer and fall.
- Follow specific recommendations in Exhibit 1.

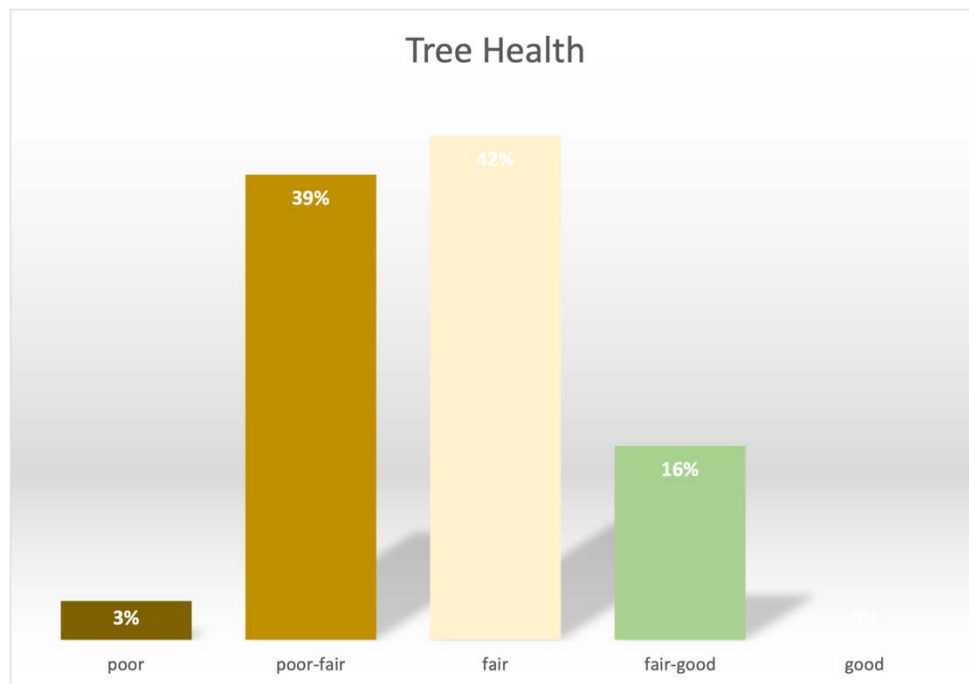
**Figure 5. Tree health ratings.**

Sixteen percent (5) of the trees were in fair-good health with no significant health concerns. Forty-two percent (13) of the trees were in fair condition and 42 percent (13) of the trees were in poor or poor-fair health (Figure 5).

All of the trees were suffering from drought stress. Due to their current condition and the severe drought this year, the trees' health will decline further (and trees will die) unless they are irrigated very soon. Even if the trees are irrigated right away, the health of the trees should be re-evaluated over the summer for the trees which are to be preserved.

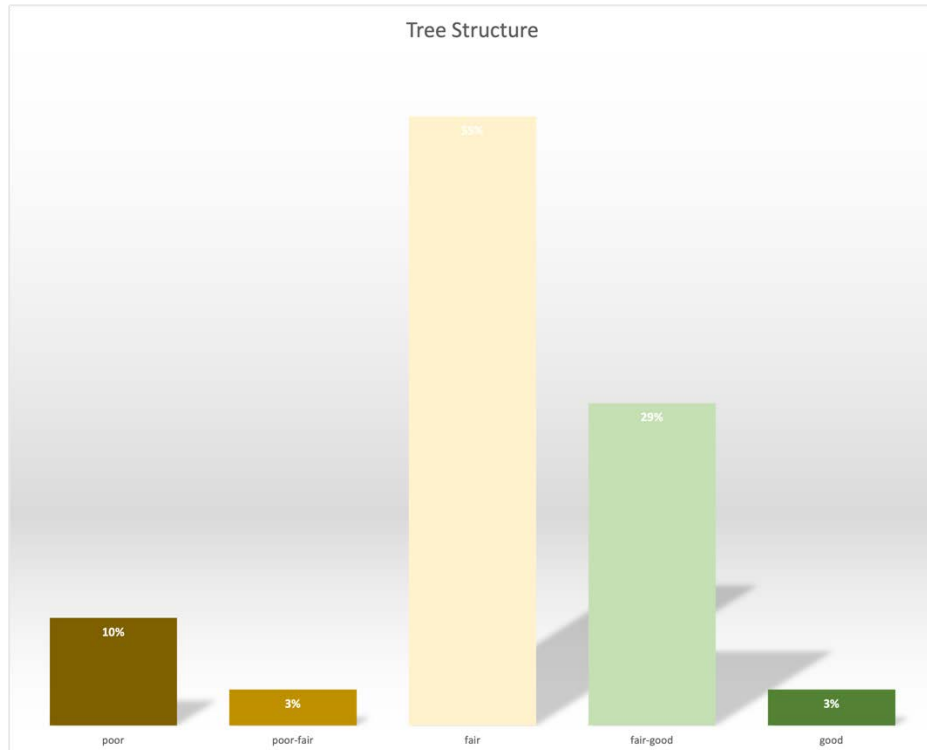
**Figure 6. Structural ratings of trees.**

Ten of the trees (32% of the total) had fair-good or good structure. Seventeen of the trees (55% of the total) had fair structure. The remaining thirteen percent (or 4) of the trees had poor-fair or poor structure (Figure 6).
