Aquatic Resources Delineation Report

Pedrick Road

Solano County
October 2023

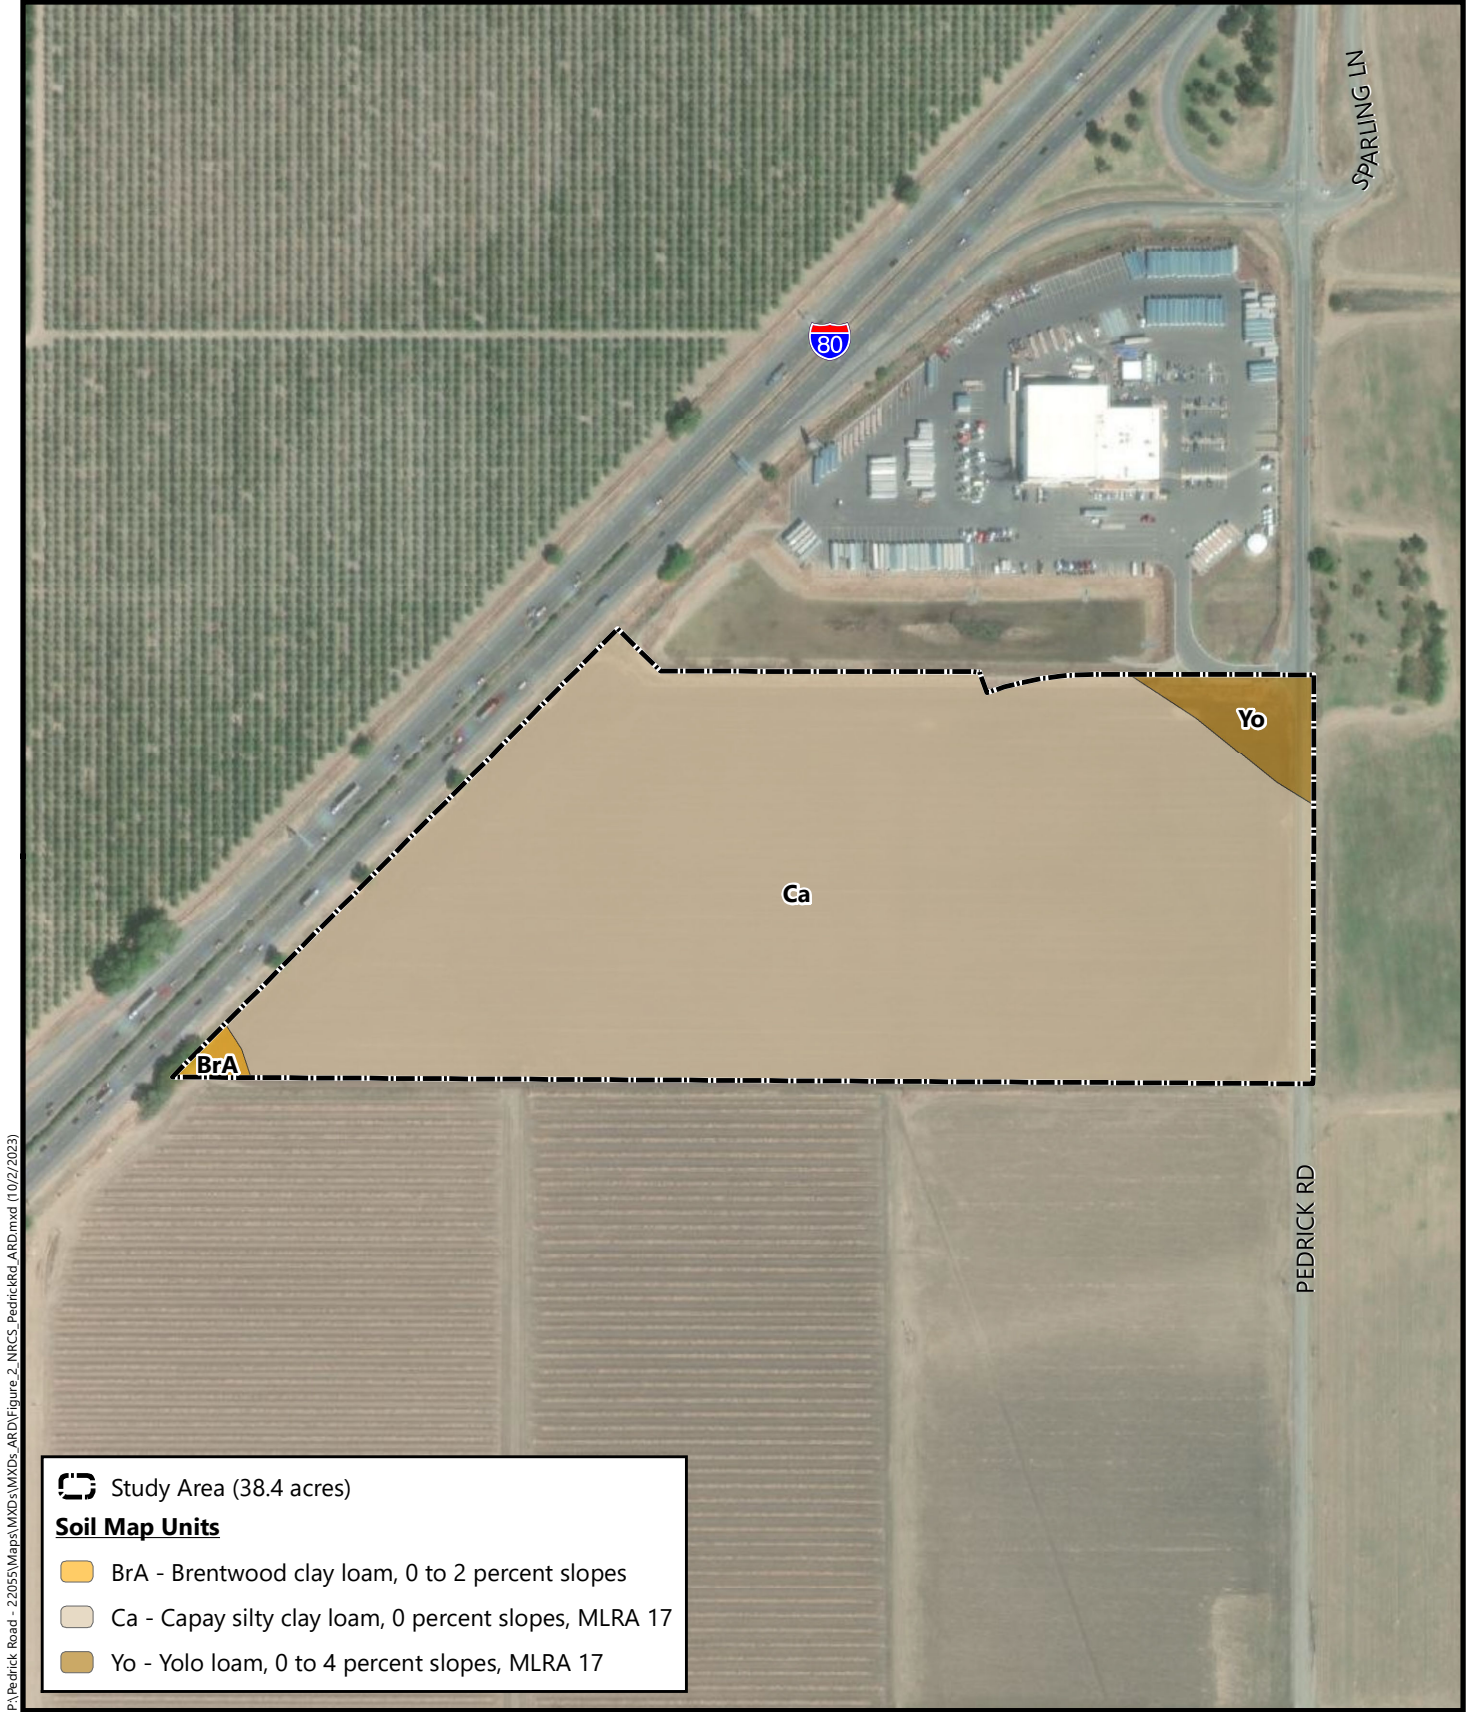
Figure 2
Natural Resources Conservation Service Soils

According to the Natural Resources Conservation Service (NRCS) Soil Survey Database (NRCS 2023a), three soil mapping units occur within the Study Area (**Figure 2**): (BrA) Brentwood clay loam, 0 to 2 percent slopes, (Ca) Capay silty clay loam, 0 percent slopes, MLRA 17, and (Yo) 0 to 4 percent slopes, MLRA 17. None of the mapped soil map units are listed in the "Hydric Soils of the United States" (NRCS 2023b) or contain recognized hydric inclusions.

BrA - Brentwood clay loam, 0 to 2 percent slopes
-

Ca - Capay silty clay loam, 0 percent slopes, MLRA 17
-

Yo - Yolo loam, 0 to 4 percent slopes, MLRA 17

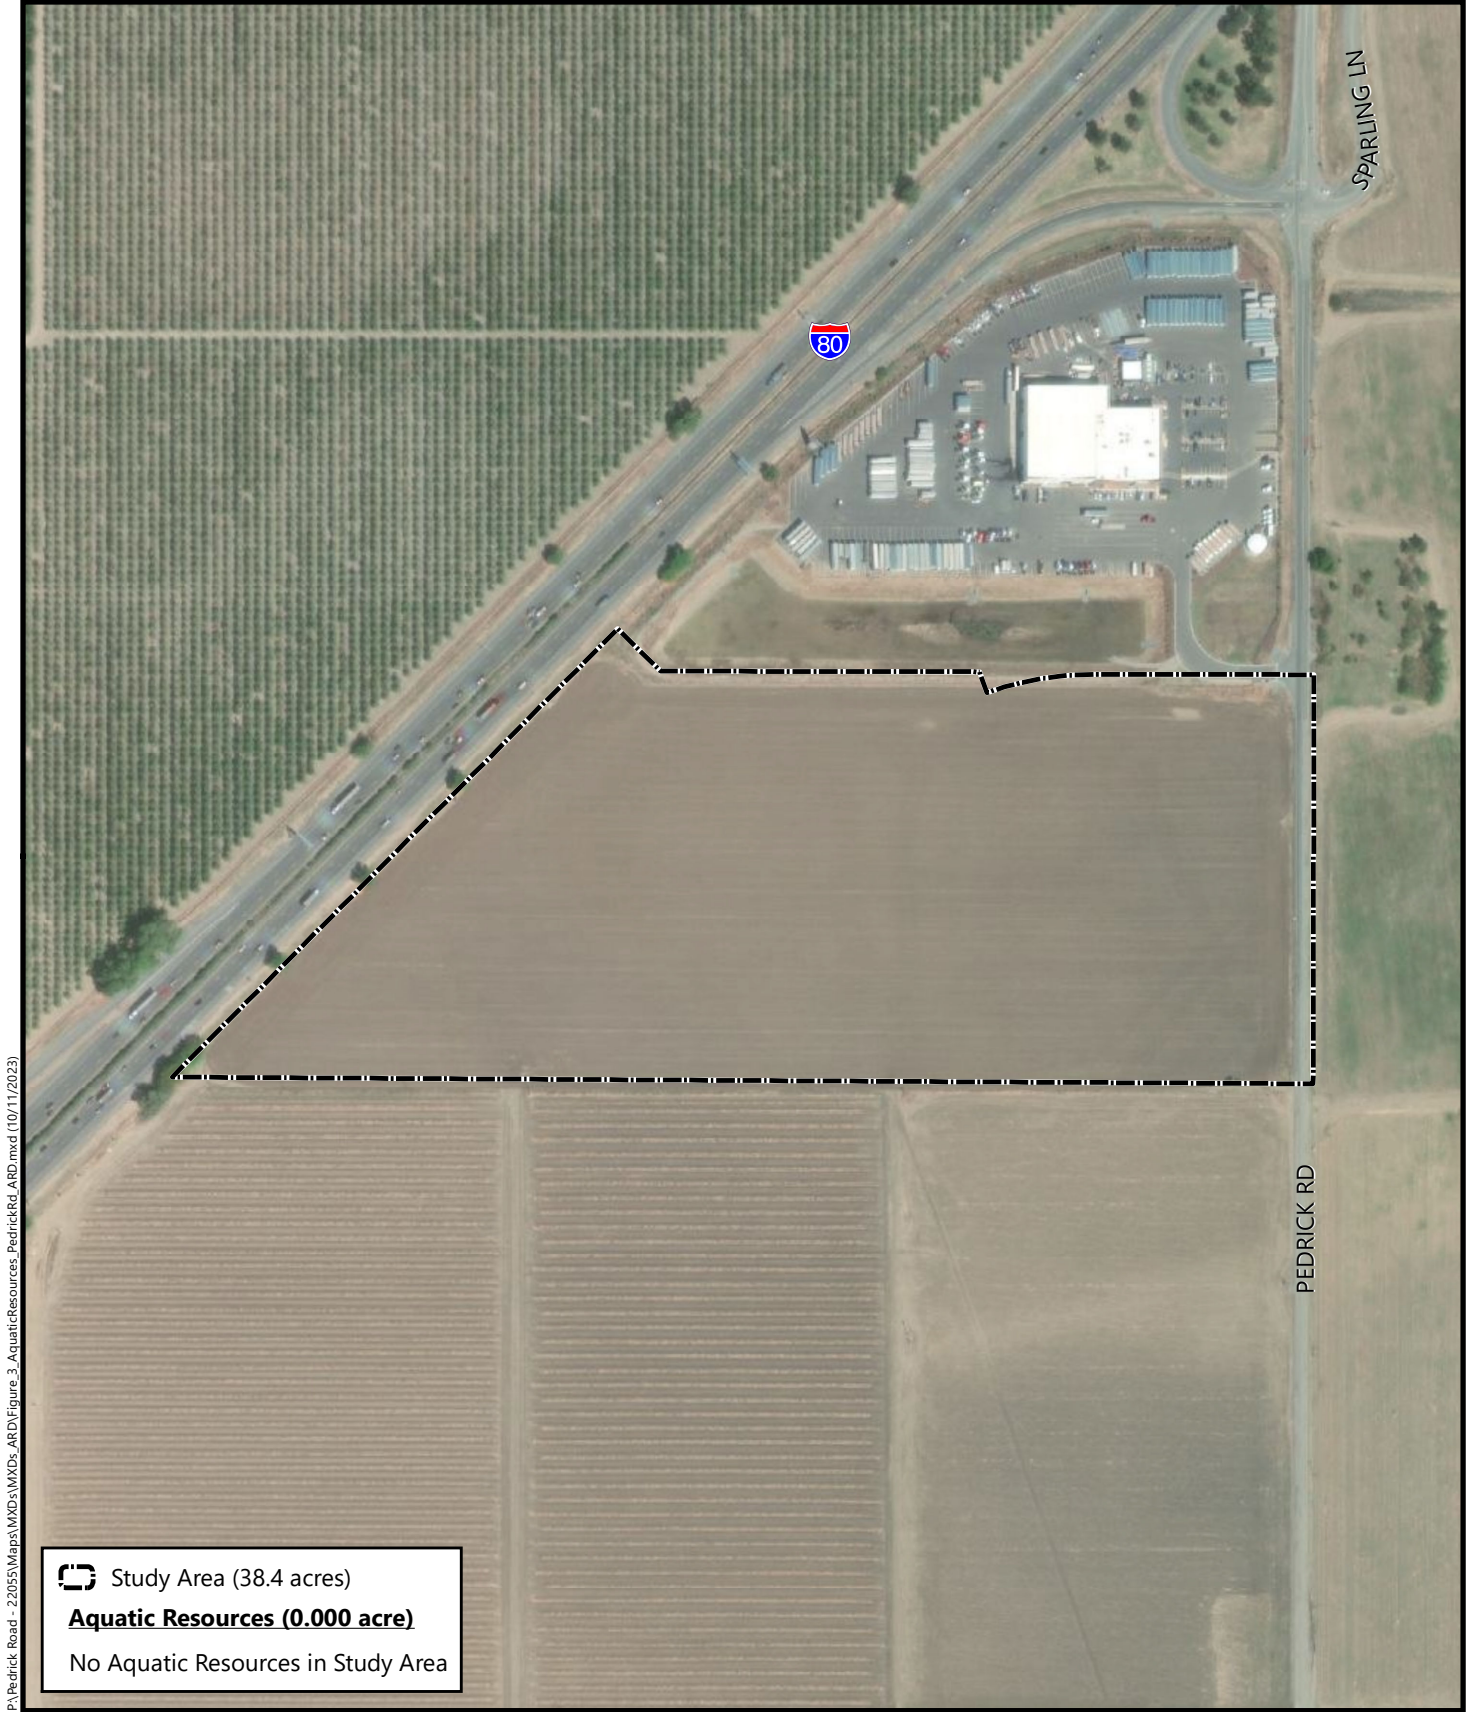
Figure 3
Aquatic Resources

No wetlands or other waters were mapped within the Study Area. The shallow roadside ditch does not meet the hydrophytic vegetation, hydric soil, and wetland hydrology criteria outlined by the USACE.

Study Area (38.4 acres)
Aquatic Resources (0.000 acre)
 No Aquatic Resources in Study Area

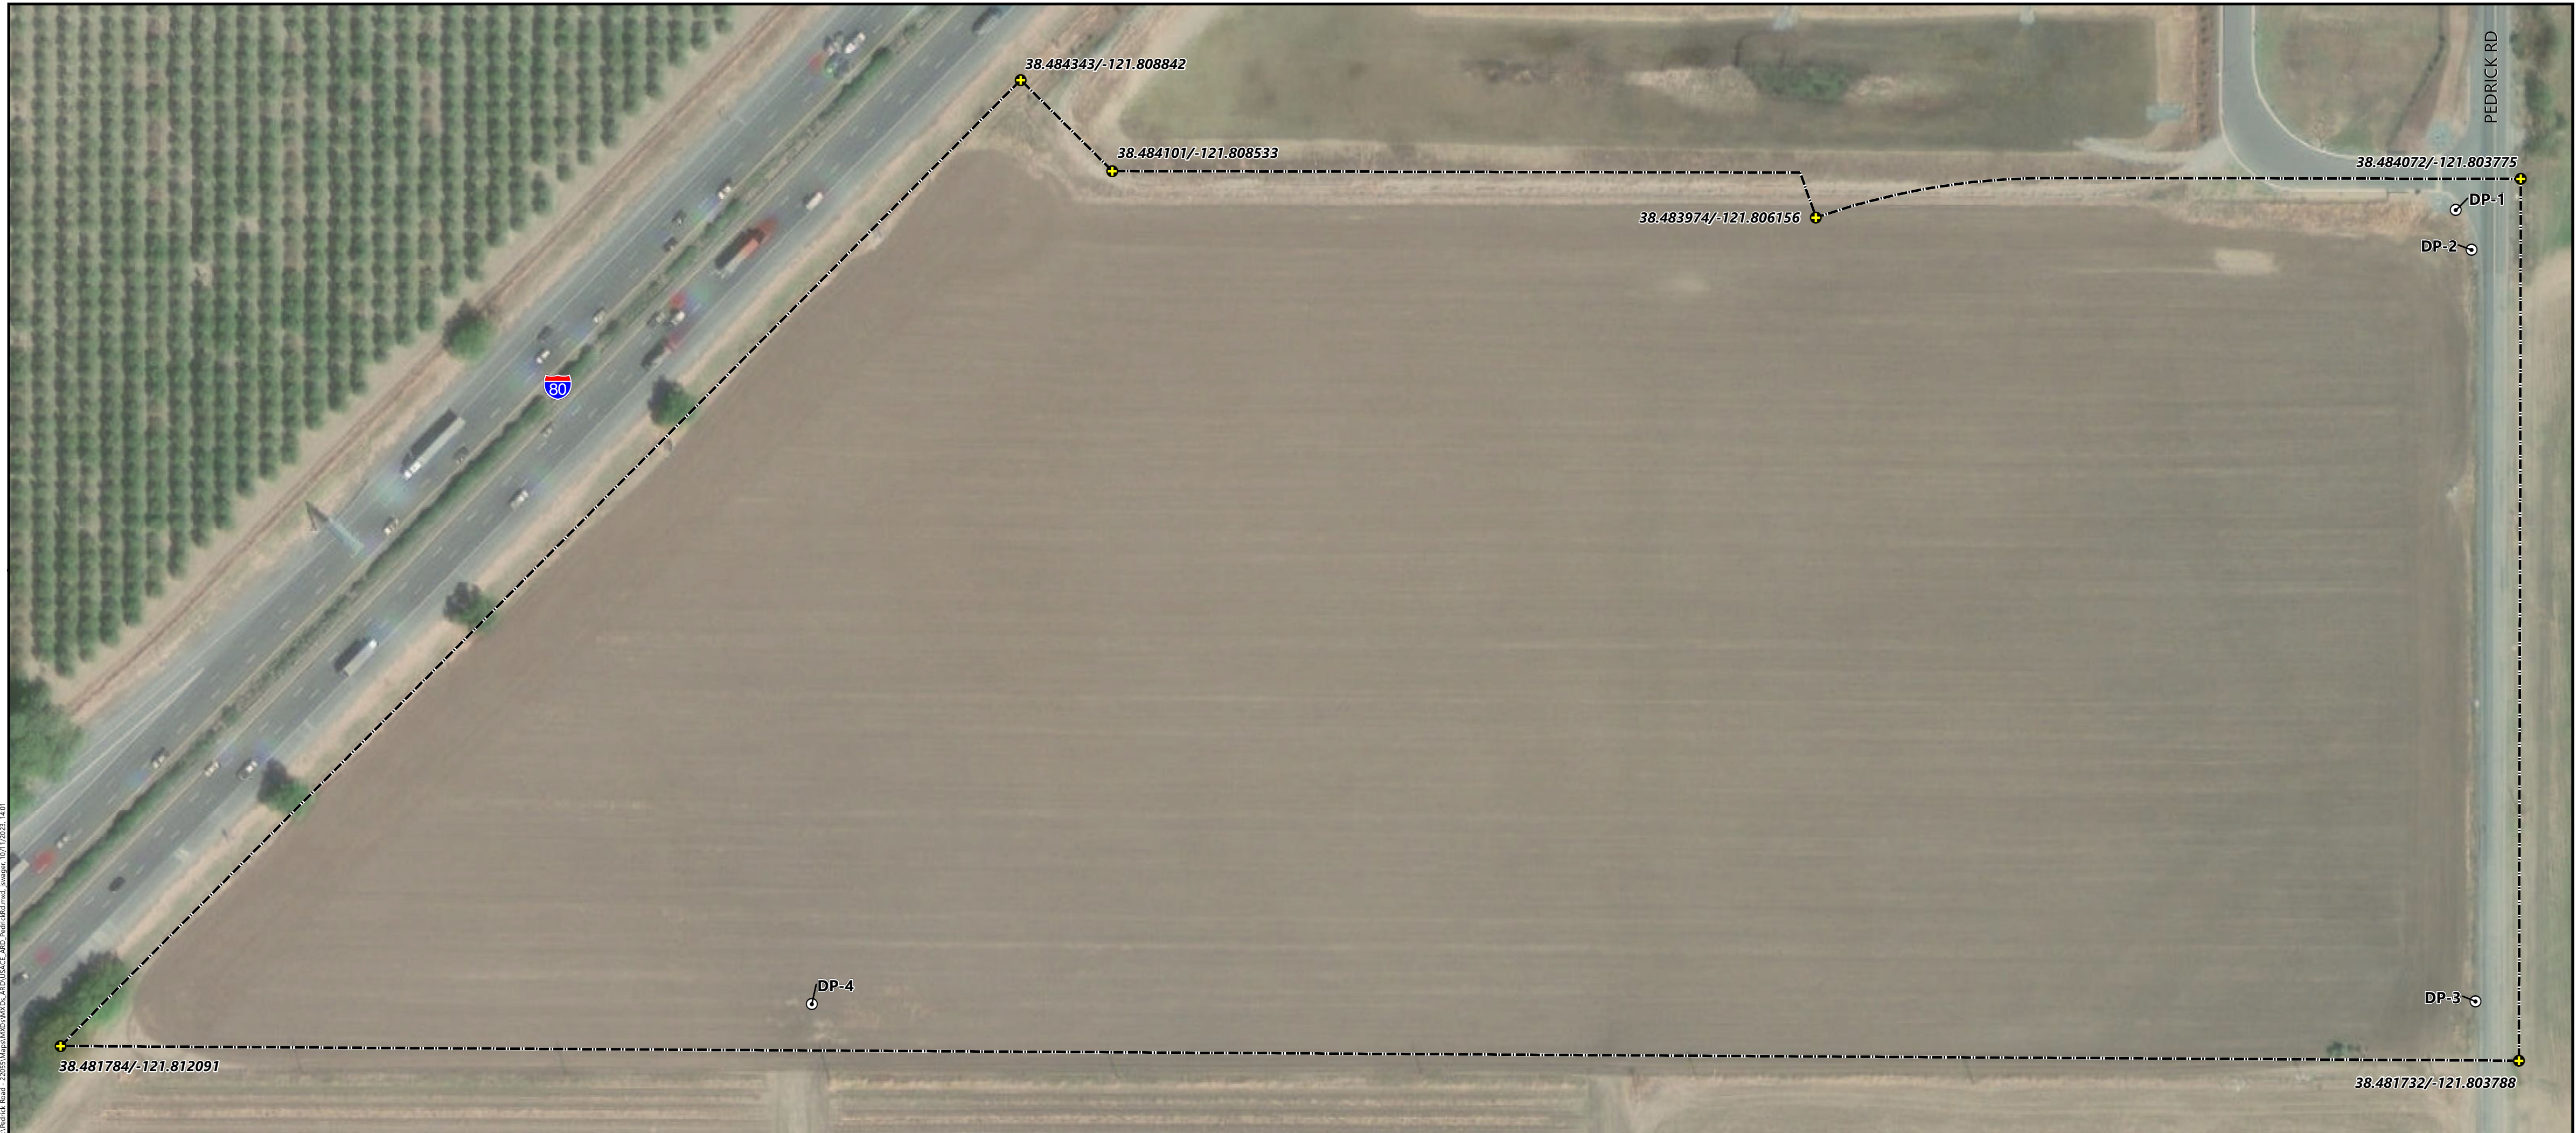
Aquatic Resources Delineation

No aquatic resources were delineated within the Study Area. Three data points were collected in a shallow roadside ditch along Pedrick Road. This ditch was designed to convey runoff from Pedrick Road into a storm drain inlet in the northeast corner of the Study Area. The ditch was partially blocked to the south and does not appear to convey regular flow as the surrounding land is relatively flat. This concrete drain inlet in the northeast corner of the Study Area receives runoff from a more substantial off-site ditch segment north of the Study Area, and directs these flows into a storm water detention basin. Data points DP-1, DP-2, and DP-3 were collected in the on-site portion of this roadside ditch. The on-site ditch has no OHWM, but is dominated by perennial ryegrass, a non-native annual grass that is classified as a facultative wetland plant species. Therefore, it does meet the wetland dominance test and is classified as containing hydrophytic vegetation. However, the loamy clay soils lacked hydric soil indicators, and are not included on the hydric soils list. The ditch does not meet the tree parameters for wetland status. With the exception of biotic crust at data point DP-1 the ditch lacks hydrology indicators. No evidence of ponding or saturation within the ditch was observed in a review of aerial imagery (Google Earth 2023).

Aquatic Resources (0.000 acre)
 No Aquatic Resources in Study Area

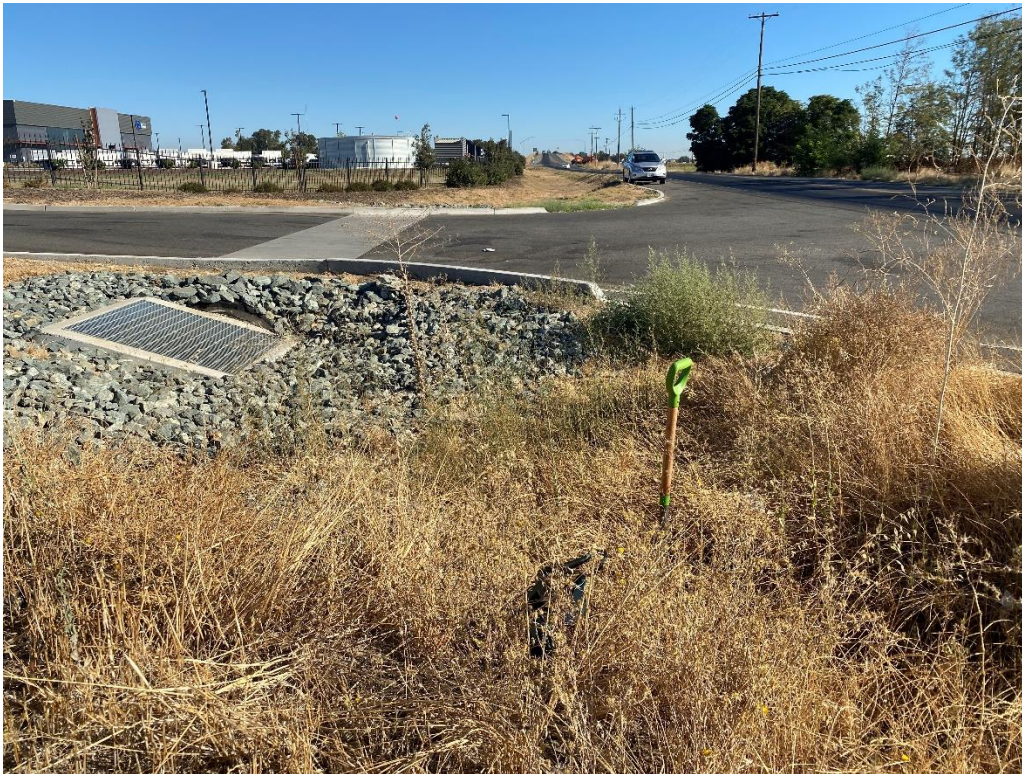
Photo DP-1 – Photo taken 2 September 2022.

Hydrophytic Vegetation Present? Yes <u>X</u> No _____ Hydric Soil Present? Yes _____ No <u>X</u> Wetland Hydrology Present? Yes <u>X</u> No _____	Is the Sampled Area within a Wetland? Yes _____ No <u>X</u>
Remarks: Point selected in a roadside ditch adjacent to a rip rap drop inlet.

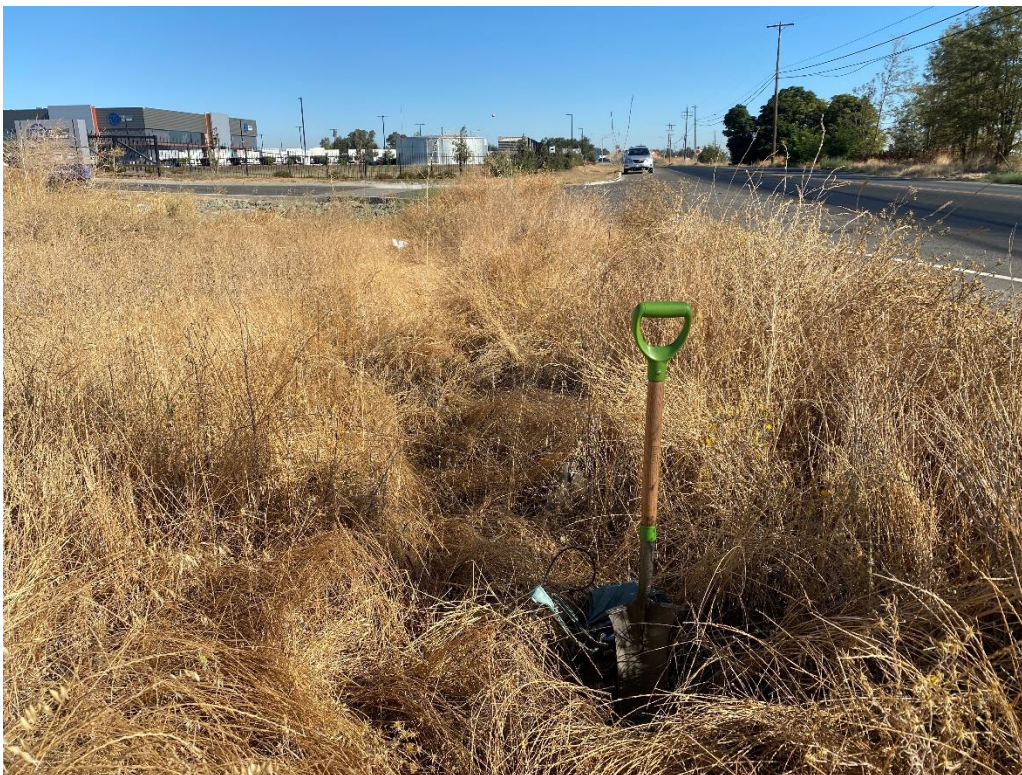
Photo DP-2 – Photo taken 2 September 2022.

Hydrophytic Vegetation Present? Yes <u>X</u> No _____ Hydric Soil Present? Yes _____ No <u>X</u> Wetland Hydrology Present? Yes _____ No <u>X</u>	Is the Sampled Area within a Wetland? Yes _____ No <u>X</u>
Remarks: Point selected in a roadside ditch.

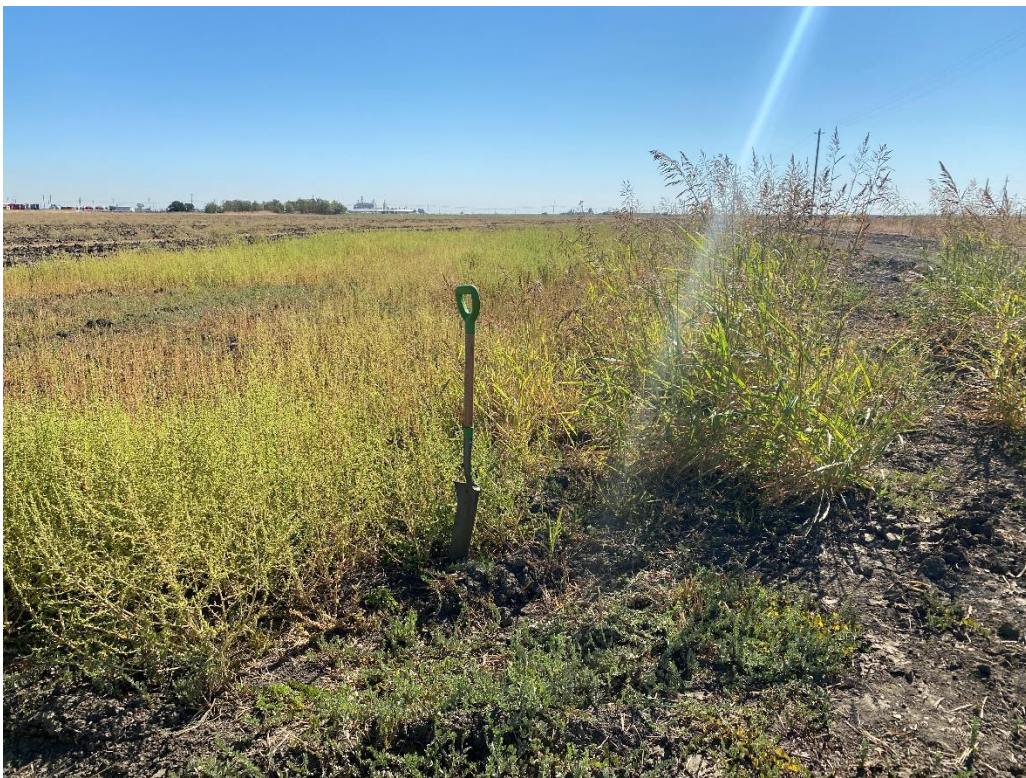
Photo DP-4 – Photo taken 2 September 2022.

An additional data point (DP-4) was collected in the fallow field based off saturation visible on the July 2021 aerial image (Google Earth 2023). This data point was dominated by weedy upland forbs and lacked hydric soils or wetland hydrology. The saturation visible on the aerial imagery appears to have been irrigation

overflow from the field to the south and not consistent enough support the development of a wetland in this location.

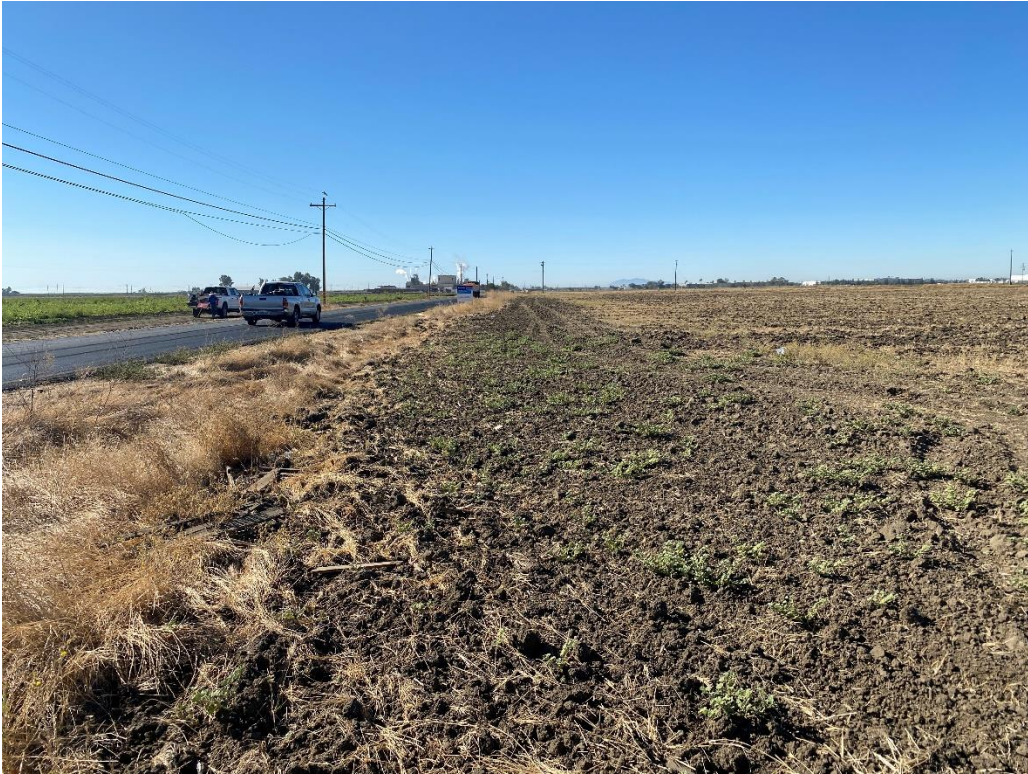
A shallow roadside ditch is located north of the Study Area and is directed through a culvert pipe into a box inlet structure in the northeastern corner of the Study Area. This box culvert drains to an off-site stormwater basin. A similarly shallow roadside feature is observable along Pedrick Road. The Study Area is dry land farmed and has been utilized as a hay field for a number of years and terrestrial plant communities in the Study Area are limited to agricultural lands and with ruderal fringes. During the April 2022 site visit the Study Area had been closely mowed, and by September it had been disked and was minimally vegetated. Scattered walnut trees (*Juglans sp.*) are located along the fringes of the Study Area along the Interstate 80 frontage.

Pedrick Road frontage including shallow roadside ditch– Photo taken 2 September 2022.

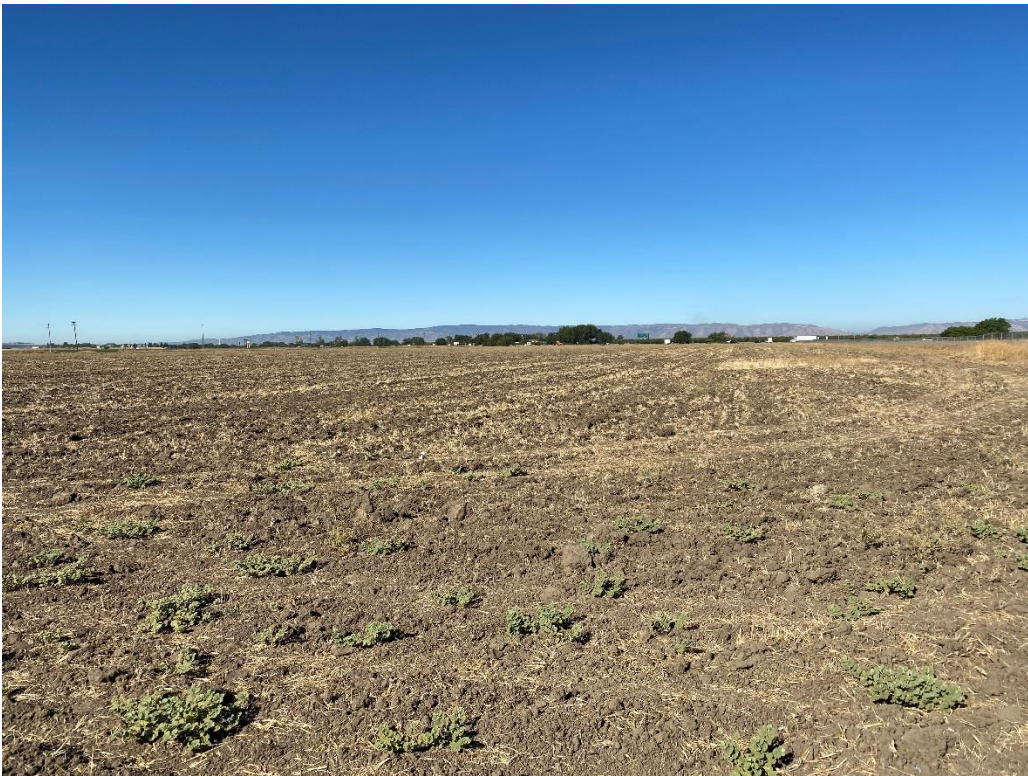
Dry farmed areas within the Study Area are regularly mowed and disked and are currently comprised of non-native annual grasses and weedy forbs. The primary crop appears to have been cultivated wheat (*Triticum aestivum*). In addition to the disked wheat, this vegetation community is dominated by tumbleweed (*Amaranthus albus*), Russian thistle (*Salsola tragus*), Johnsongrass (*Sorghum halepense*), common purslane (*Portulaca oleracea*), silver sheath knotweed (*Polygonum argyrocoleon*), alkali mallow (*Malvella leprosa*), filaree (*Erodium botrys*), Bermuda grass (*Cynodon dactylon*), prickly lettuce (*Lactuca scariola*), and winter vetch (*Vicia villosa*). Undisturbed areas along Pedrick Road and Highway 80 frontages include perennial ryegrass (*Festuca perennis*), filaree, wintervetch, yellow starthistle (*Centaurea solstitialis*), slender wild oat (*Avena barbata*), and (*Galium aparine*).

Typical upland agricultural field– Photo taken 2 September 2022.
