NORTHEAST QUADRANT SPECIFIC PLAN

**ENVIRONMENTAL IMPACT REPORT
TECHNICAL APPENDICES**

SEPTEMBER 1994

VAUGHN ROAD PSA
Dixon, Solano County, California

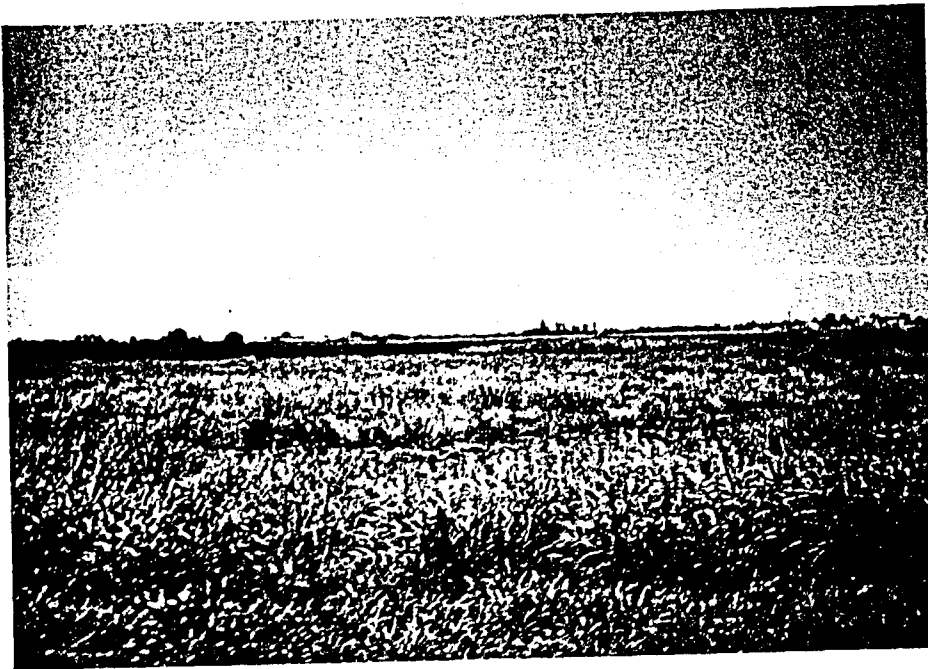
(Above) Generalized view of agricultural fields on property.

(Below) Left-building housing plumbing business
Right-building housing Bartholomew-Enterprises
Construction business.

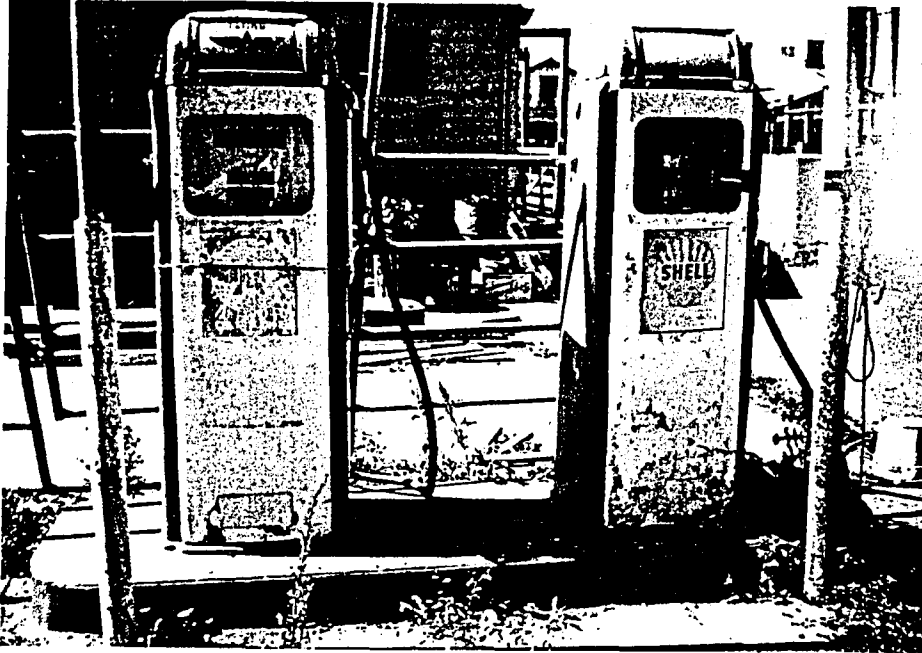
(Above) Fuel dispensers, Dixon Livestock Auction Yard.

Near the barn, located on the north side of the yard, were two fuel dispensers, and two tank fill pipes. The dispensers and fill pipes appeared to be 30 to 40 years old, or older. Also near the tanks were a number of 55 gallon drums, some of which contained what appeared to be used motor oil. We also observed a five gallon plastic bucket containing used motor oil and water, which had overflowed and stained the concrete pavement below. Near the dispensers was a vehicle lift rack, operated by an air compressor. The barn itself contained:
