DUFFEL 13 DIXON PROPERTY
DIXON, CALIFORNIA

PRELIMINARY GEOTECHNICAL REPORT

PROJECT NO.
16329.000.000

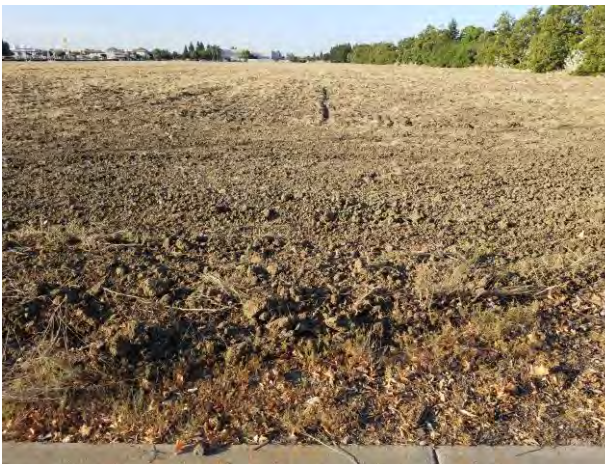
PHOTO 2.4-1:
Site conditions, looking south.

At the time of our field exploration, the Duffel 13 site was relatively level, and appeared to have been recently disced. A moderate to heavy growth of dry grasses and weeds was present at a tree line at the western property boundary. While no topographic information was provided, the surface elevations from Google Earth indicate the area slopes gently to the east, with site grades ranging from approximately Elevation 63 to 69 feet (Datum WGS84). Sidewalks with adjacent streetlights and utility access boxes and manholes were present at Vaughn Road / North Lincoln Street at the northern property boundary and North 1st Street / State Route 113 at the eastern property boundary. Several utility risers / stubs were observed behind the sidewalks to the north and east.

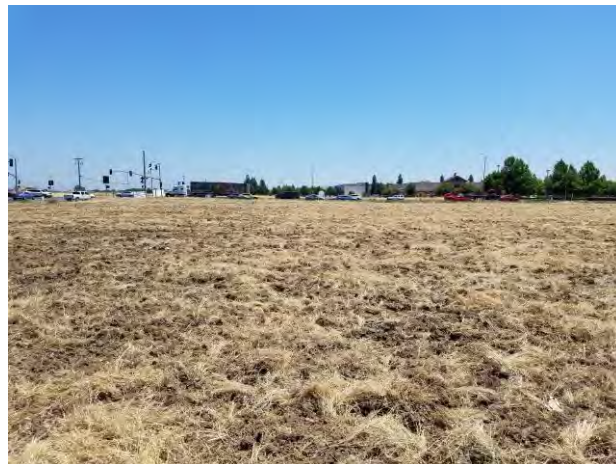
PHOTO 2.4-2:
Site conditions, looking northeast.

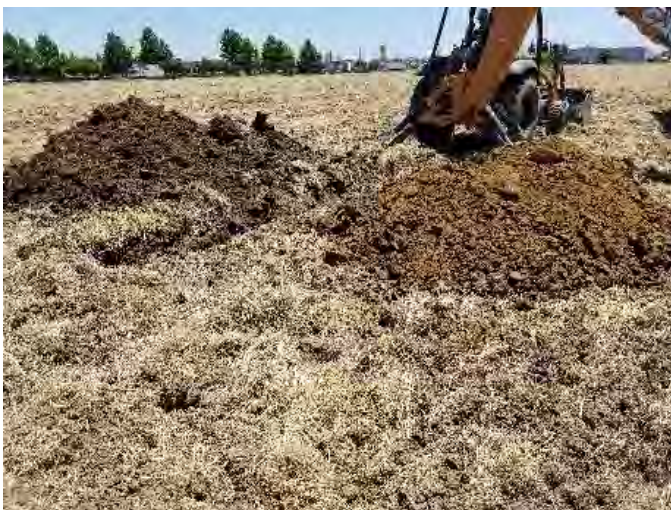
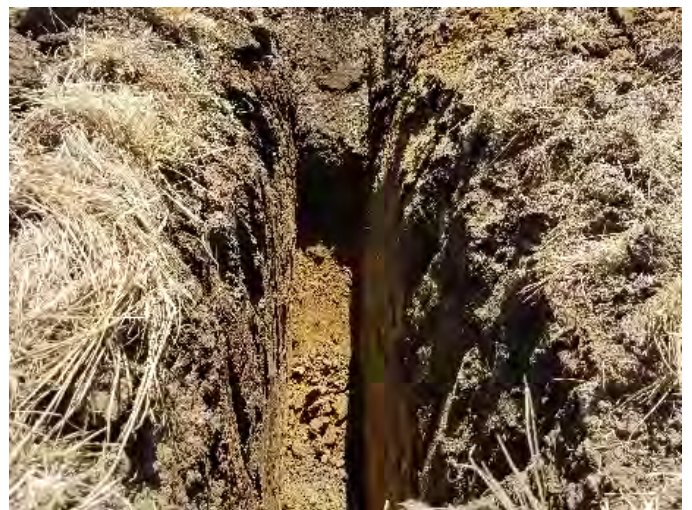
Logged By: S. Blakely
Logged Date: July 3, 2019
Equipment: Case 850N EP Backhoe

Depth (Feet)	Description	Depth of Sample/ Lab Test (Feet)	Plasticity Index	Liquid Limit	Laboratory Moisture Content%	Fines Content (% passing #200 sieve)
0 - 9	LEAN CLAY (CL), dark brown, very stiff, moist, medium plasticity, medium toughness, approximately 5-10% fine-grained sand.	1½	30	47		89.2
2	grades to brown					
4½	grades to dark yellowish brown, 11% fine-grained sand	5				
9 - 10½	SANDY LEAN CLAY (CL), dark yellowish brown, hard, moist, low plasticity, low toughness, approximately 30% fine- to medium-grained sand, cemented, no HCl reaction, cemented nodules and ichnofossils.					
10½	Bottom of test pit at 10½ feet. No groundwater encountered.

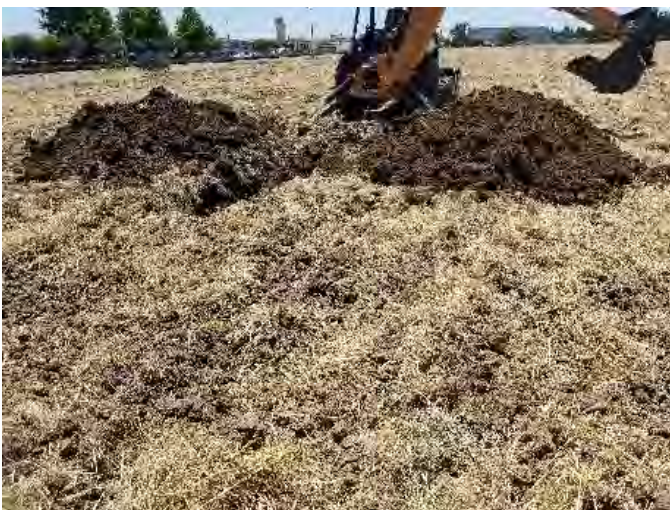
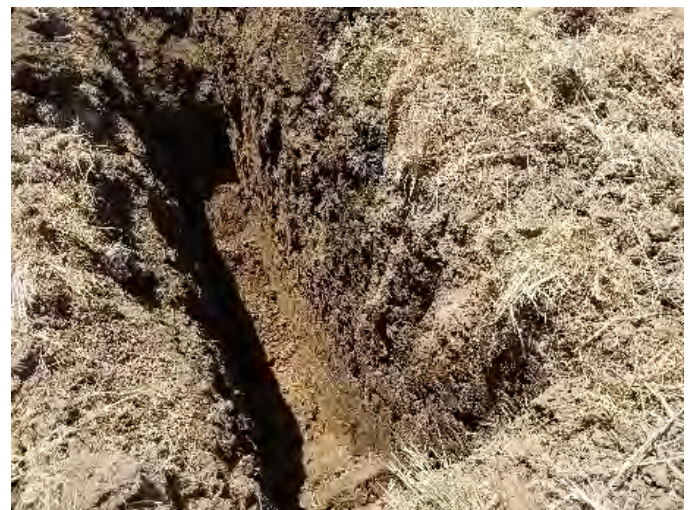
TEST PIT LOG TP2

Depth (Feet)	Description	Depth of Sample/ Lab Test (Feet)	Plasticity Index	Liquid Limit	Laboratory Moisture Content%	Fines Content (% passing #200 sieve)
0-1½	LEAN CLAY WITH GRAVEL (CL), dark brown, very stiff, moist, low to medium plasticity, low to medium toughness, approximately 20% angular to subrounded fine to coarse gravel, approximately 5-10% fine-grained sand [Fill].					
1½-3½	LEAN CLAY (CL), dark brown, very stiff, moist, medium plasticity, medium toughness, 10% fine-grained sand, trace coarse-grained sand and subangular fine gravel [Fill].	1½			19.8	90.4
3½-10½	LEAN CLAY (CL), dark yellowish brown, very stiff, moist, medium plasticity, medium toughness, 6% fine-grained sand. [Native]	4			20.4	93.5
10	few cemented clay nodules					
10½	Bottom of test pit at 10½ feet. No groundwater encountered.

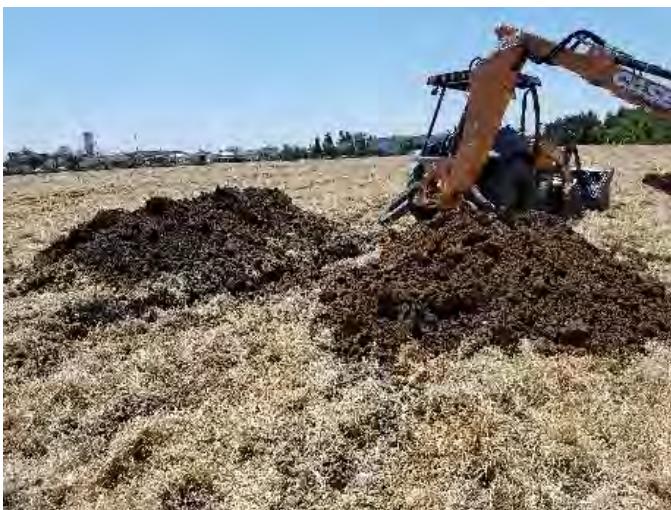
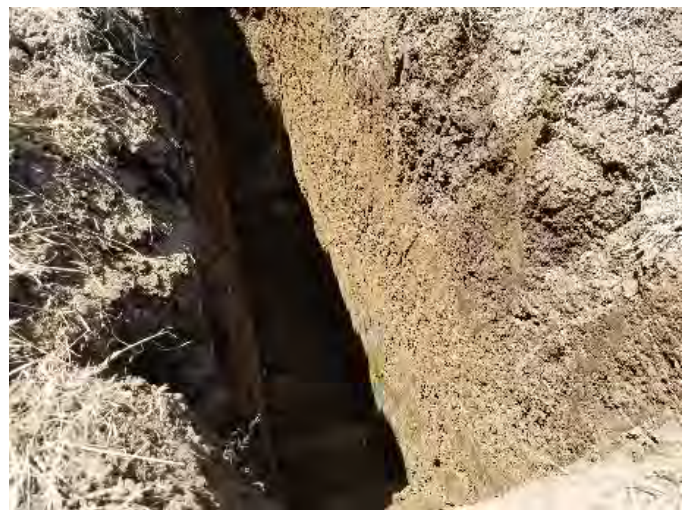
TEST PIT LOG TP3

Depth (Feet)	Description	Depth of Sample/ Lab Test (Feet)	Plasticity Index	Liquid Limit	Laboratory Moisture Content%	Fines Content (% passing #200 sieve)
0-1½	SANDY LEAN CLAY WITH GRAVEL (CL), brown, very strong, slightly moist, low plasticity, low toughness, approximately 25% fine- to coarse-grained sand, approximately 15% angular to subrounded fine to coarse gravel [Fill].					
1½-10½	LEAN CLAY (CL), dark brown, hard, moist, medium plasticity, medium toughness, approximately 5-10% fine-grained sand. [Native]					
2	grades to brown, very stiff					
4½	grades to dark yellowish brown	5			19.9	
10	few cemented clay nodules					
10½	Bottom of test pit at 10½ feet. No groundwater encountered.

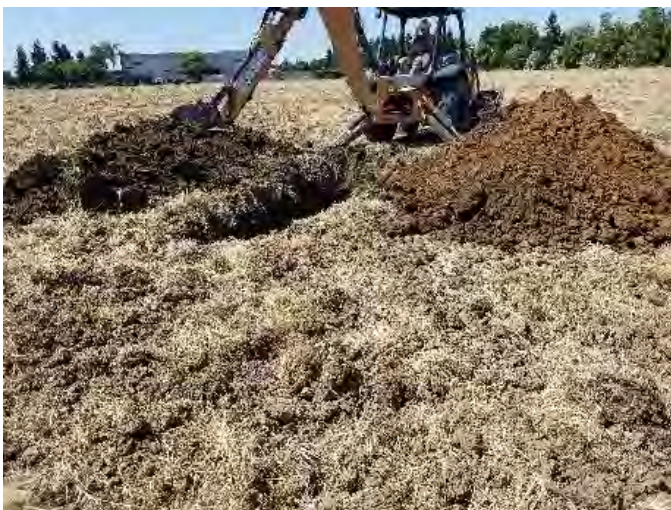
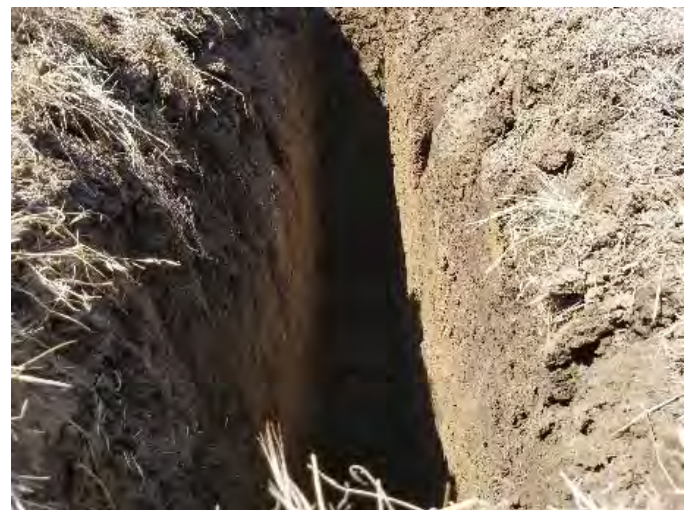
TEST PIT LOG TP4

Depth (Feet)	Description	Depth of Sample/ Lab Test (Feet)	Plasticity Index	Liquid Limit	Laboratory Moisture Content%	Fines Content (% passing #200 sieve)
0-11½	LEAN CLAY (CL), dark brown, hard, moist, medium plasticity, medium toughness, 8% fine-grained sand.	1½	28	45		92.4
2½	grades to brown, very stiff, medium to high plasticity, medium to high toughness					
8½	grades to dark yellowish brown					
10½	grades to yellowish brown, a few cemented clay nodules					
11½	Bottom of test pit at 11½ feet. No groundwater encountered.

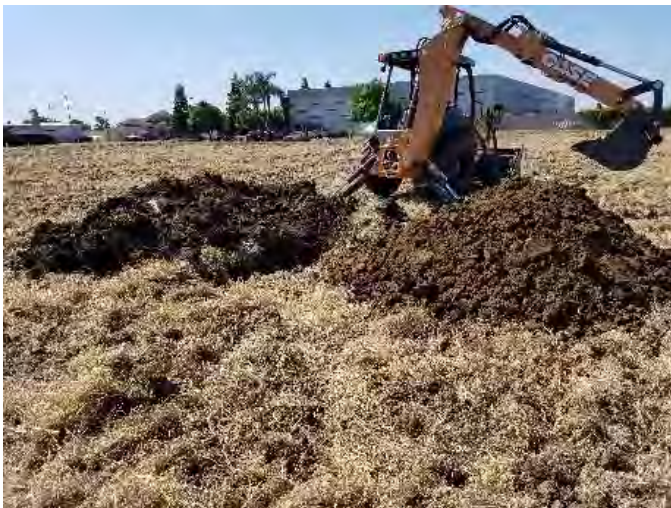
TEST PIT LOG TP5

Depth (Feet)	Description	Depth of Sample/ Lab Test (Feet)	Plasticity Index	Liquid Limit	Laboratory Moisture Content%	Fines Content (% passing #200 sieve)
0-12½	LEAN CLAY (CL), dark brown, hard, moist, medium plasticity, medium toughness, approximately 5-10% fine-grained sand.					
2½	grades to brown, very stiff					
10½	grades to yellowish brown	10			19.5	
11½	grades to dark yellowish brown, medium to high plasticity, medium to high toughness	12			19.2	
12½	Bottom of test pit at 12½ feet. No groundwater encountered.

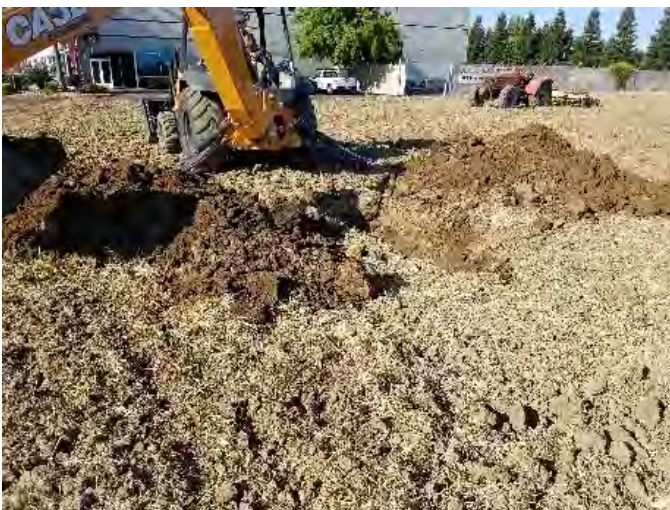
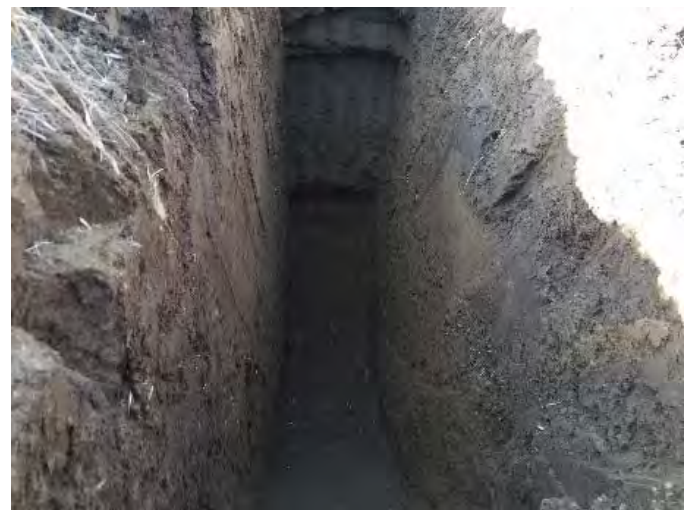
TEST PIT LOG TP6

Depth (Feet)	Description	Depth of Sample/ Lab Test (Feet)	Plasticity Index	Liquid Limit	Laboratory Moisture Content%	Fines Content (% passing #200 sieve)
0-10½	LEAN CLAY (CL), brown, hard, moist, medium plasticity, medium toughness, 14% fine- to coarse-grained sand.	1			15.4	86.1
1½	grades to medium to high plasticity, medium to high toughness, approximately 5-10% fine-grained sand					
2½	grades to very stiff					
4	grades to yellowish brown, medium plasticity, low to medium toughness					
10½	Bottom of test pit at 10½ feet. No groundwater encountered.

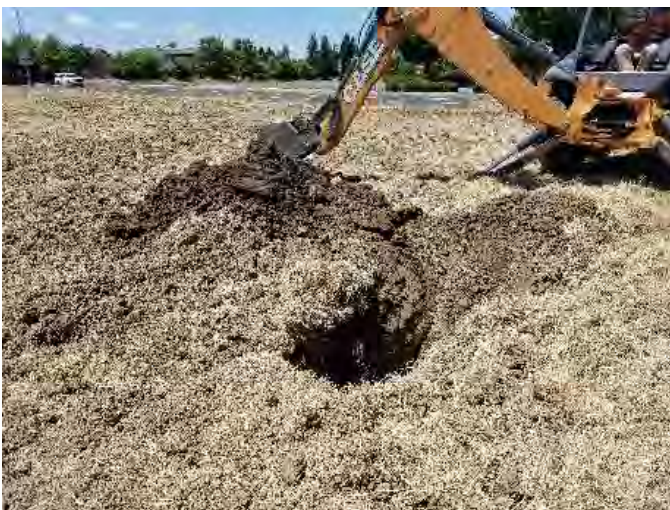
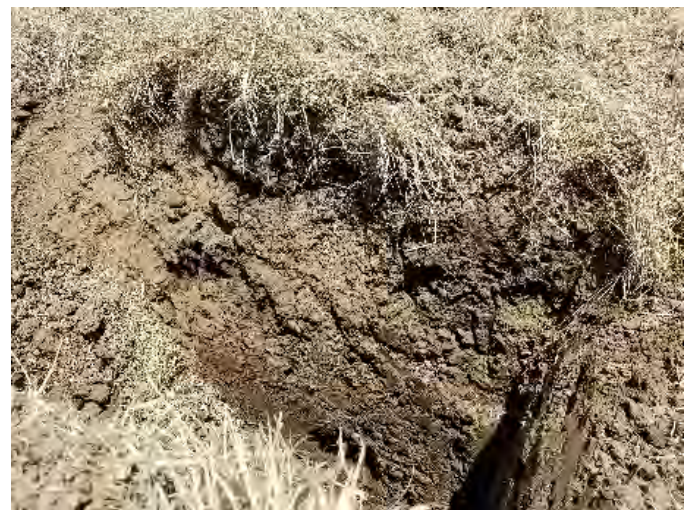
TEST PIT LOG TP7

Depth (Feet)	Description	Depth of Sample/ Lab Test (Feet)	Plasticity Index	Liquid Limit	Laboratory Moisture Content%	Fines Content (% passing #200 sieve)
0-3	SANDY LEAN CLAY WITH GRAVEL (CL), dark brown, very stiff, slightly moist, medium plasticity, medium toughness, approximately 30% fine- to coarse-grained sand, approximately 10% angular to subrounded fine gravel [Fill].	2-3			12.8	
3-4	LEAN CLAY (CL), dark brown, hard, moist, medium to high plasticity, medium toughness, approximately 5-10% fine-grained sand. [Native]	3-4			22.5	
4	Bottom of test pit at 4 feet. No groundwater encountered.
