DIXON 257
DIXON, CALIFORNIA

GEOTECHNICAL EXPLORATION

PREPARED BY
ENGEO Incorporated

February 4, 2022

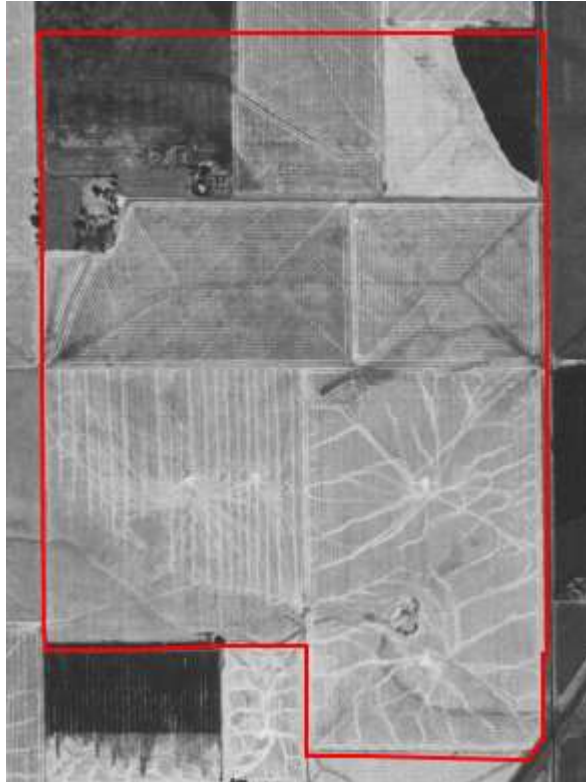
EXHIBIT 2.2.1-1: Former Drainages and Topographic Depression on Historical Map and Photograph

Exhibit 2.2.1-1 below shows excerpts from the 1937 aerial photograph and 1952 USGS topographic map showing the former drainages and topographic depression. The locations of these former features are also shown on our Site Plan, Figure 2.

1937 Aerial Photograph

1952 USGS Topographic Map

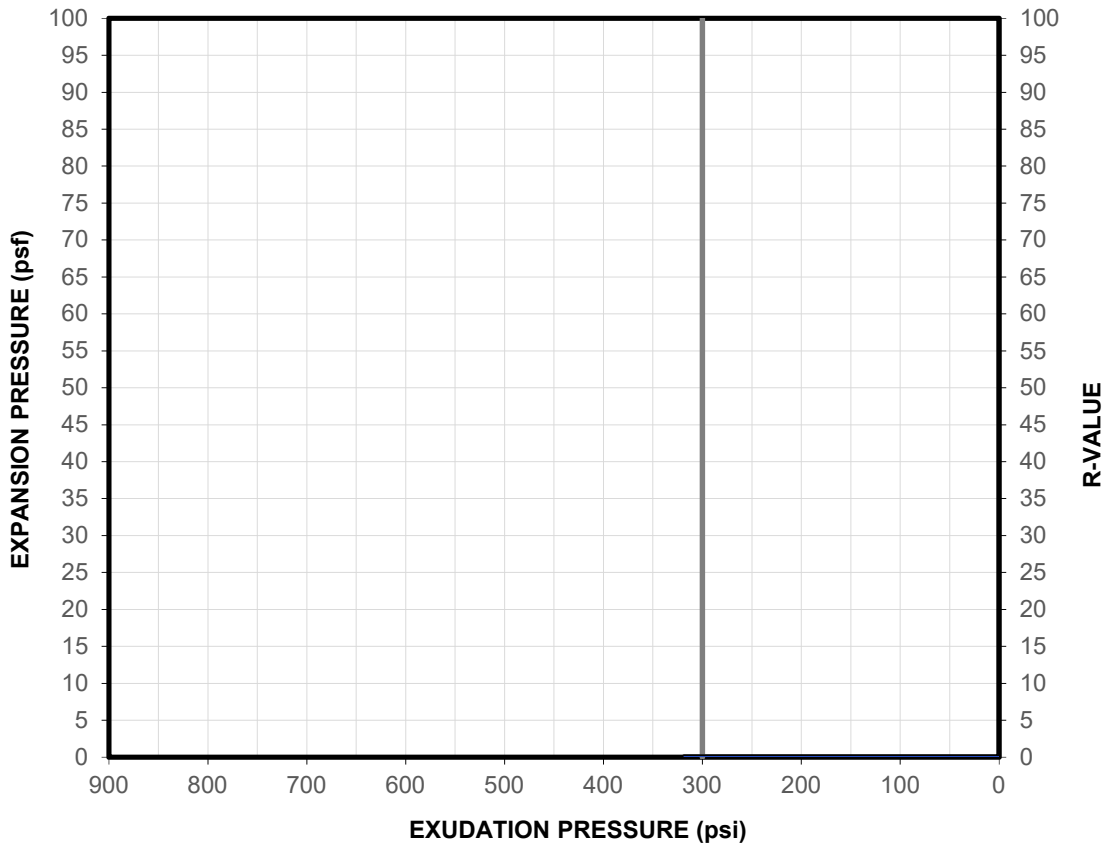
R-VALUE TEST REPORT

SAMPLE ID	MATERIAL DESCRIPTION	SAMPLE LOCATION		
1-B1@0	See exploration logs	1-B1 at 0 feet		
SPECIMENS		1 *	2	3
EXUDATION PRESSURE (psi)		318	0	0
EXPANSION PRESSURE (psf)		n/a	0	0
R-VALUE		< 5	n/a	n/a
MOISTURE CONTENT (%)		28.7	n/a	n/a
DRY DENSITY (pcf)		n/a	n/a	n/a
EXPANSION PRESSURE (psf) AT EXUDATION PRESSURE OF 300 psi		n/a		
R-VALUE AT EXUDATION PRESSURE OF 300 psi		TEST RESULT		
		Less than 5

* Soil extruded under the mold with less than 5 lights.

Expansive soil generally provides poor subgrade support for roadways, as indicated by the low R-value laboratory test results included in Appendix B. A low R-value results in thicker pavement structural sections than a higher R-value. If desired to reduce the pavement section thickness, the roadway subgrade can be lime-treated to increase the R-value for design. We provide lime treatment recommendations in Section 5.7 and provide pavement design options in Section 9.1.

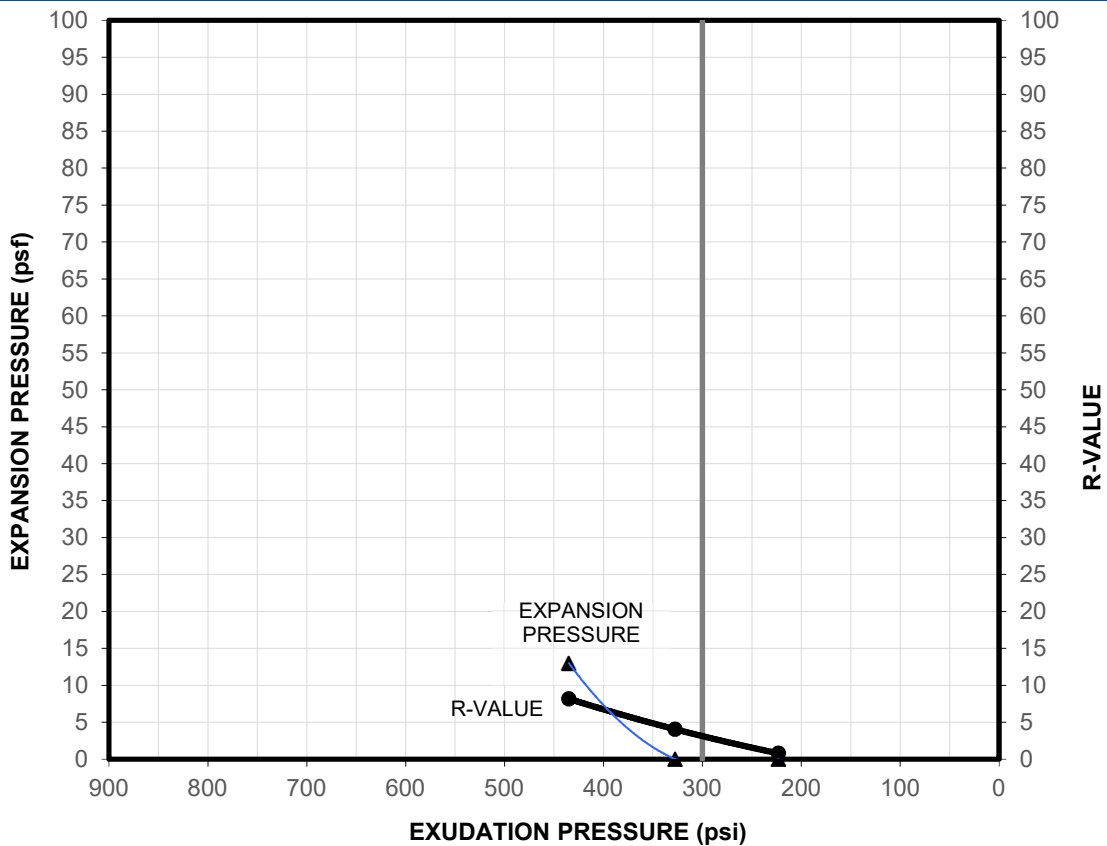
R-VALUE TEST REPORT

SAMPLE ID	MATERIAL DESCRIPTION	SAMPLE LOCATION		
1-B3@0	See exploration logs	1-B3 at 0 feet		
SPECIMENS		1	2	3
EXUDATION PRESSURE (psi)		435	328	223
EXPANSION PRESSURE (psf)		13	0	0
R-VALUE		8	4	1
MOISTURE CONTENT (%)		42.7	44.7	46.7
DRY DENSITY (pcf)		83.8	81.6	79.6
EXPANSION PRESSURE (psf) AT EXUDATION PRESSURE OF 300 psi		0		
R-VALUE AT EXUDATION PRESSURE OF 300 psi		TEST RESULT		
		3
